Project UpWind

Contract No.: 019945 (SES6) "Integrated Wind Turbine Design"

ENVIRONMENTAL DEGRADATION OF GLASS FIBRE REINFORCED POLYMER COMPOSITE

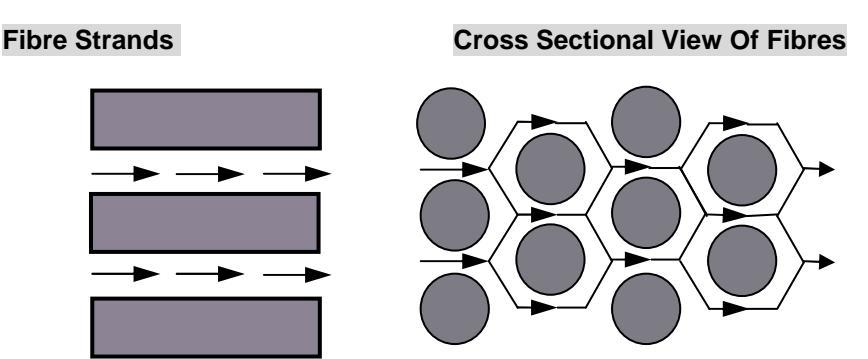
Fig. 1.1 Diffusion path of moisture into composite thickness direction [24]

Fibre composites, are increasingly being used in renewable energy generation applications (wind turbine rotor blades) owing to several desirable properties including high flexural strength, high specific stiffness, lightweight, controlled anisotropy. Despite these advantages over conventional structural materials such as metals, composites are susceptible to heat and moisture when operating in harsh and changing environmental conditions. When exposed to humid environments, Glass fibre–epoxy composites absorb moisture (Fig. 1.1) and undergo volumetric expansion.

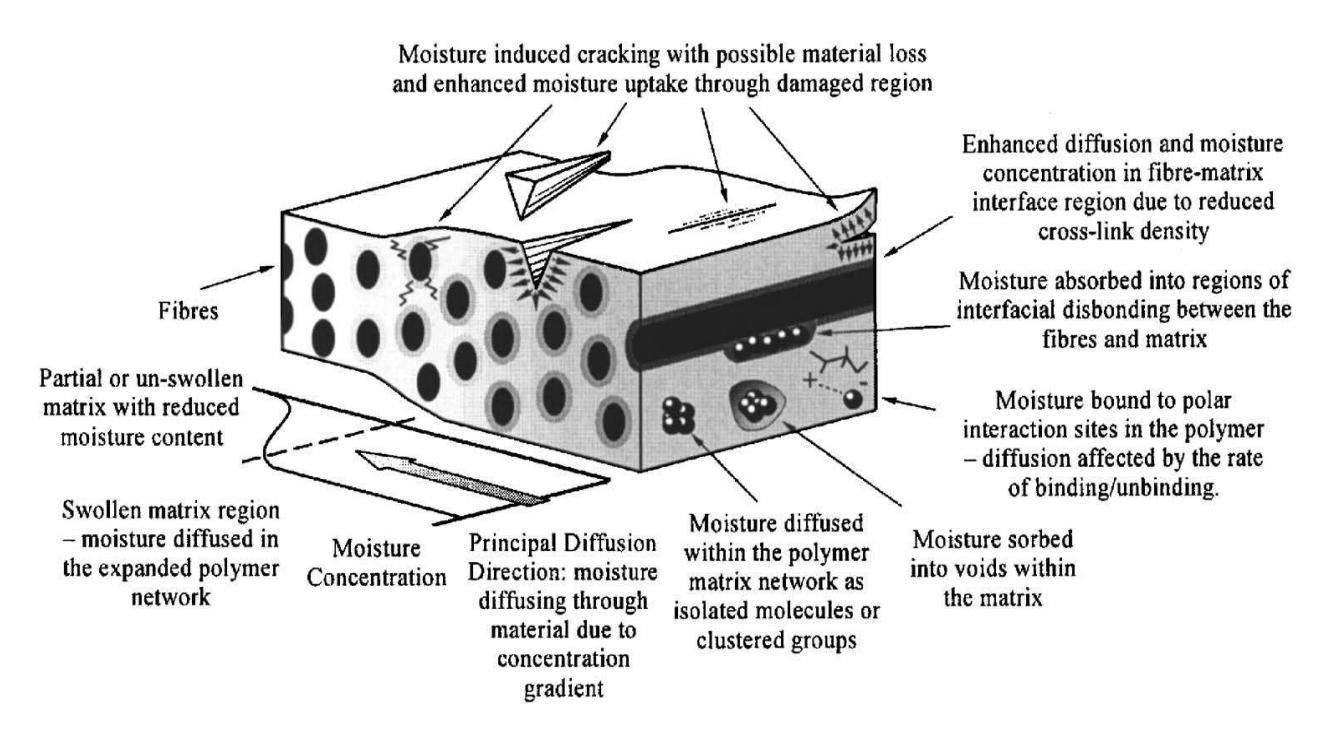
Fig. 1.2 Different effects of moisture diffusion on composites [12]

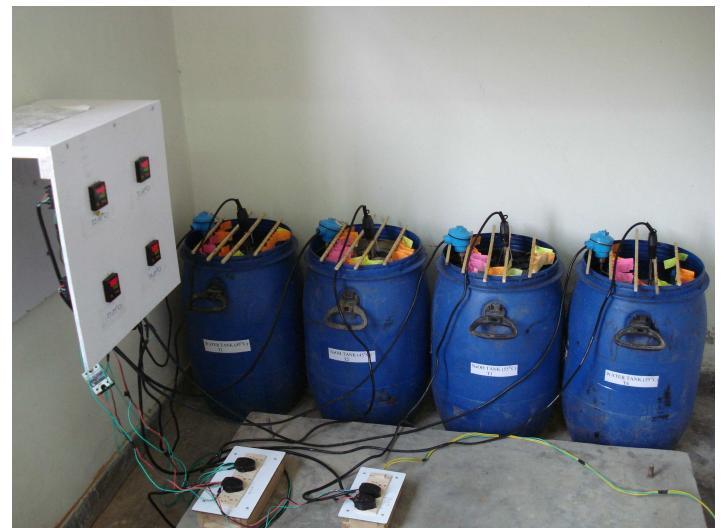
Fig. 2.1 Experimental setup

The specimen were immersed in various baths for different time durations. The novelty of the experiment was that the accelerated environmental exposure had been given to specimen while they were pre-stretched to different service loads. The specimen were removed from the bath after decided time period. The Ultimate tensile strength was measured and a SEM (Scanning Electron Microscope) image was obtained to check the condition of composite material.

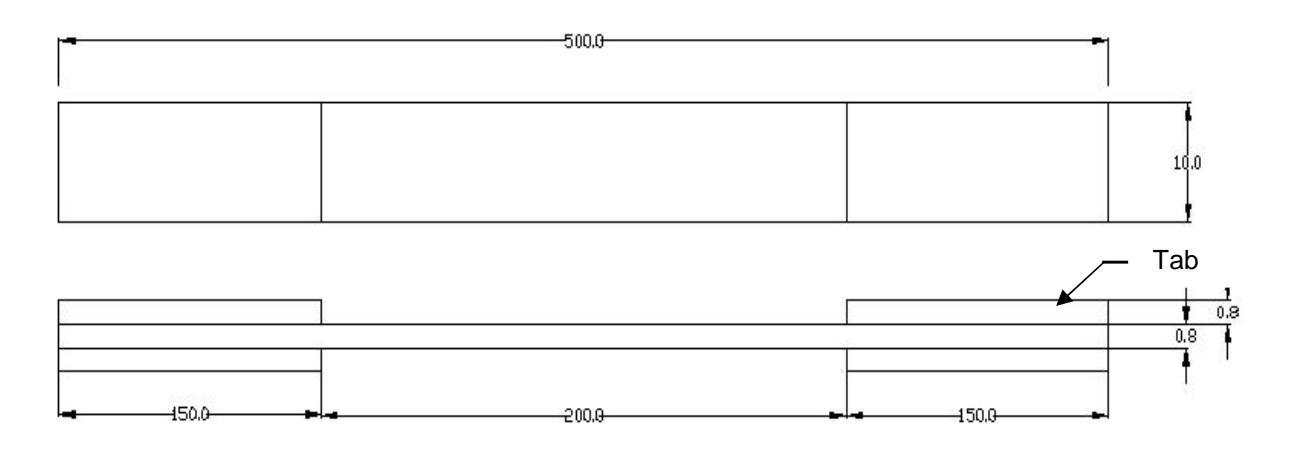
Fig. 2.2 Dimensions of the Specimen

All dimensions are in mm

The specimen were having "tabs" at both sides only upto a length of 150 mm from respective ends. This left an "effective length" of about 200 mm in centre. We had taken the ASTM Standard D-3039 as a reference to decide the shape and specification of the specimen.

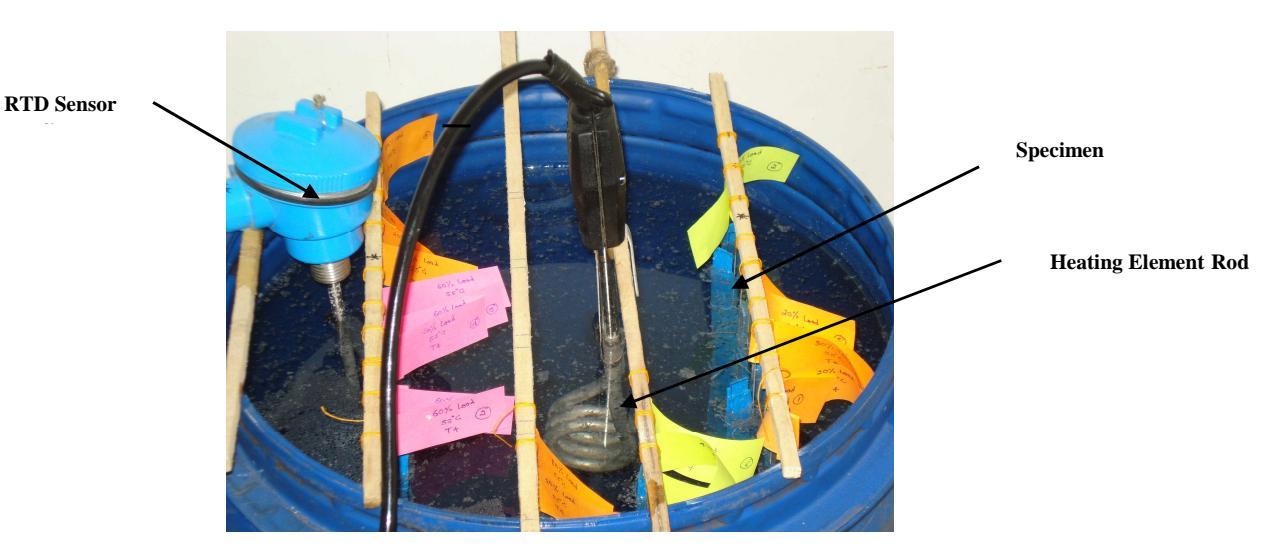
Fig. 2.4 Heating Element and RTD sensor in a bath

The image of the specimen is shown in Fig.2.3. The specimen hung were fully immersed into the bath from a hanger stick with help of thread as shown in Fig.2.4.

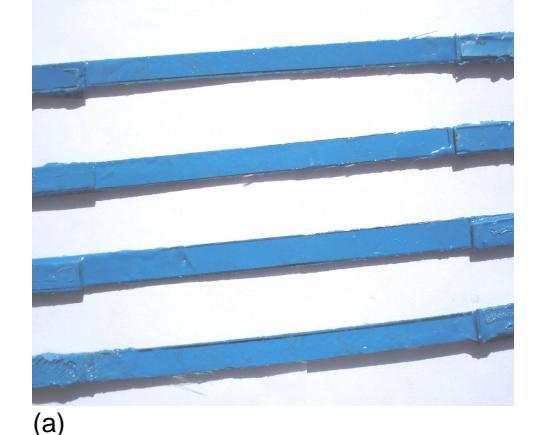
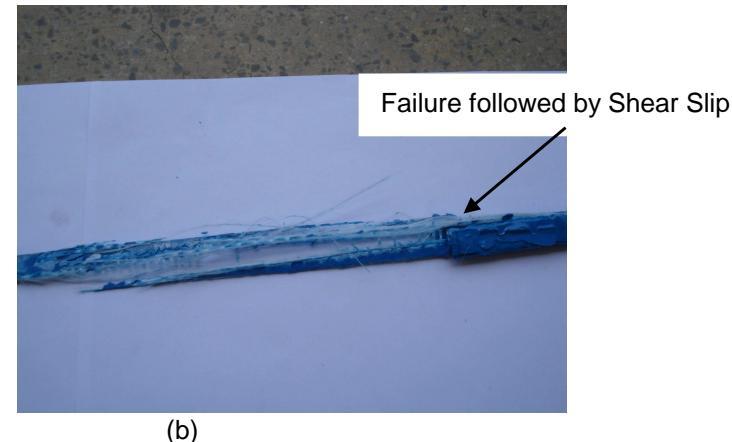
Fig. 3.1 Fresh specimen (a) before tension test (b) after tension test

As per the visual observation the initial specimen (Fig.3.1) had fine shiny epoxy coating and the failure of such specimen under uniaxial tensile load showed a broom type failure with long broom fibres which is typical of sudden and violent release of stored elastic energy at failure.

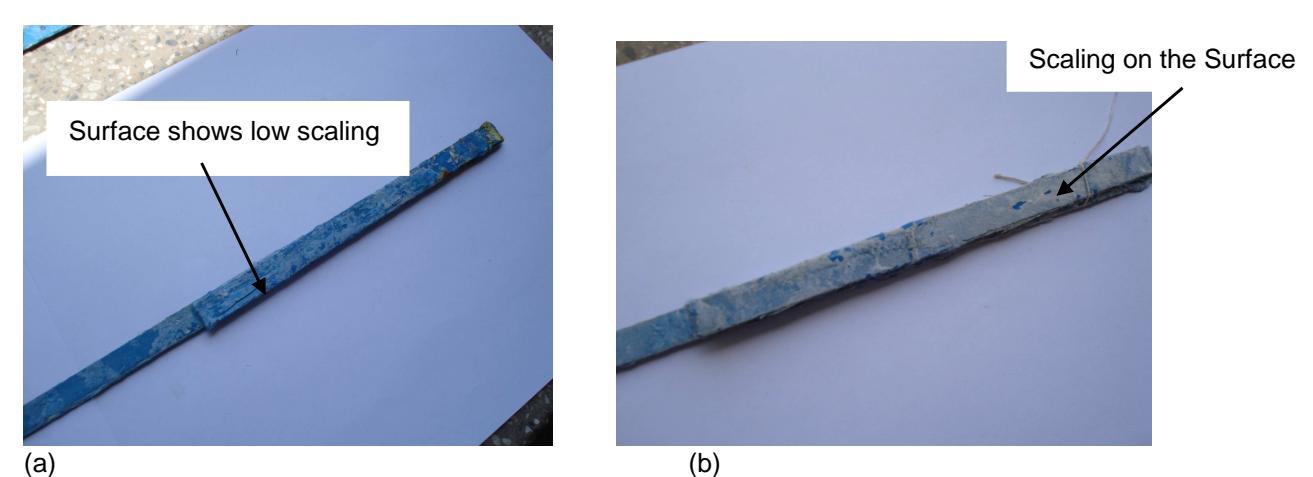
Fig. 3.2 Specimen taken out after one month of exposure (a) NaOH bath (b) Water bath

After 1 month (Fig. 3.2 and Fig. 3.3) of exposure in water baths there was heavy visible scale formation on all the specimen. Surface observation showed that epoxy had lost its shine and outer edges on either side showed little fanning out. But still after bending (by hands) the specimen showed considerable strength and flexibility. Broom type failure was visible though with shorter broom fibre.

On the other hand the specimen immersed in aqueous NaOH baths had deteriorated to a large extent, the top surface of some specimen showed the chipping out of epoxy coating which appeared to have gone brittle. Further the specimen had lost their flexibility and were easily broken by bending with hands.

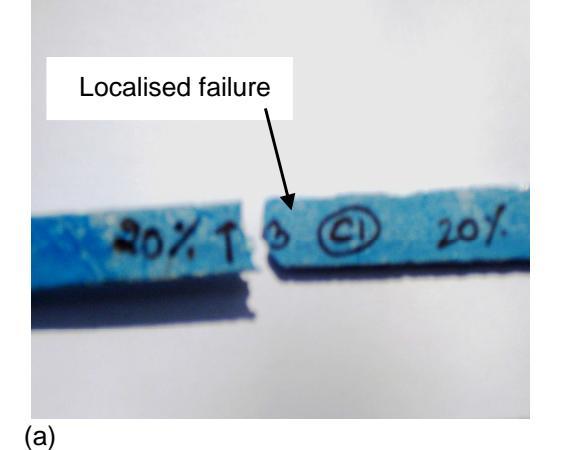
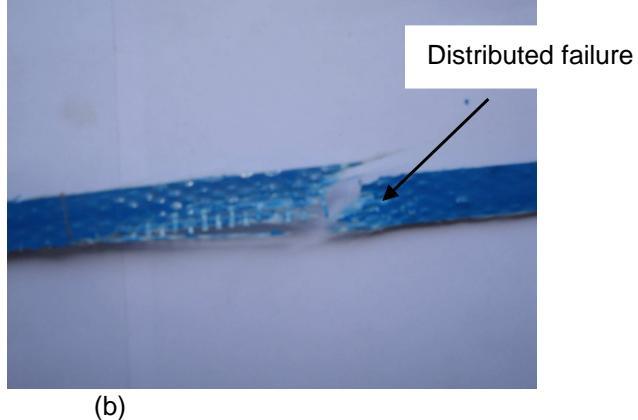
Fig. 3.3 Failure in tensile held after one month exposure (a) NaOH bath (b) Water bath

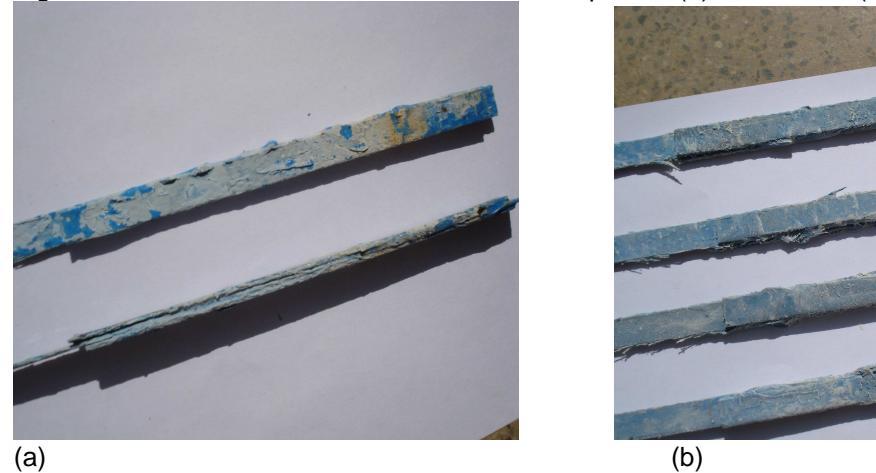
Fig.3.4 Specimen taken out after two months of exposure (a) NaOH bath (b) Water Bath

After 2 months (Fig.3.4 and Fig.3.5) of environmental exposure in water baths observations of degradation and heavy scaling were noted with more scale formation on water immersed specimen as compared to first month observations for water immersed specimen. Broom type failure with shorter broom fibre as compared to one month exposed fibres was visible.

For 2 months (Fig.3.4 and Fig.3.5) of environmental exposure in NaOH baths observations of heavy degradation of fibre and scaling were noted with more fibre degradation of NaOH bath immersed specimen as compared to first month observations for NaOH bath immersed specimen. Clean Abrupt failure like cleavage edge was visibly observed. The specimen had lost their flexibility completely and were easily broken by slight bending with hands as compared to one month exposed specimen.

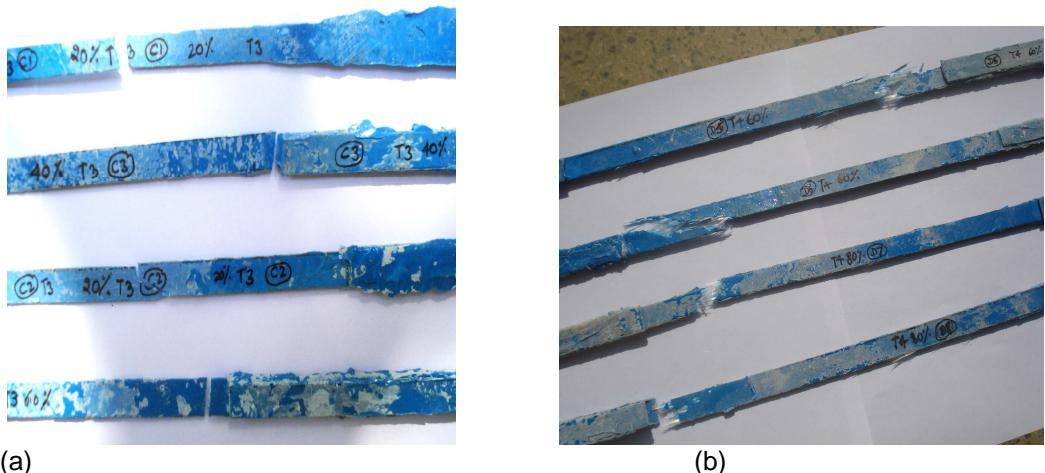
Fig. 3.5 Failure in tensile held after two month exposure (a) NaOH bath (b) Water Bath

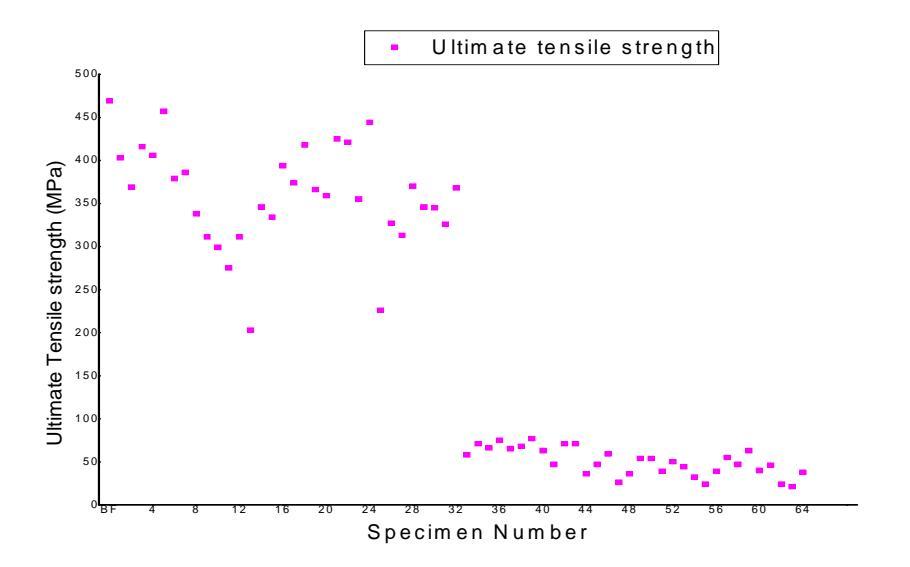
The Fig. 3.6 shows the ultimate tensile strength of all the specimen. It is clearly seen that the specimen immersed in water have fairly higher level of strength as compared to the ones immersed in aquous NaOH bath. From the graphs (Fig. 3.7 - Fig. 3.8) it is seen that for both water and NaOH environments with increasing time of exposure the ultimate tensile strength of specimen decrease. The graphs (Fig.3.9 - Fig.3.12) show the effect of temperature on degradation in ultimate tensile strength for water and NaOH baths. It is observed that for water bath the decrease in ultimate tensile strength is similar in both the baths at 45 and 55 degree Celsius for all specimen, whereas in case of NaOH baths the decrease in ultimate tensile strength is much more pronounced in the bath at 55 degree Celsius. Graphs (Fig. 3.13 - Fig. 3.20) show the effect of varying pre-stretch loads on the ultimate tensile strength of the specimen immersed in water and NaOH baths. It is observed that in water baths with the variation pre-stretch loads a decrease in ultimate tensile strength is observed for all specimen, Also for NaOH baths (Fig 3.18-Fig 3.20) it is observed that with increasing pre-stretch loads there is a decrease in ultimate tensile strength for all specimen.

Fig. 3.6 Comparison of ultimate tensile strength of specimen in NaOH and Water Baths

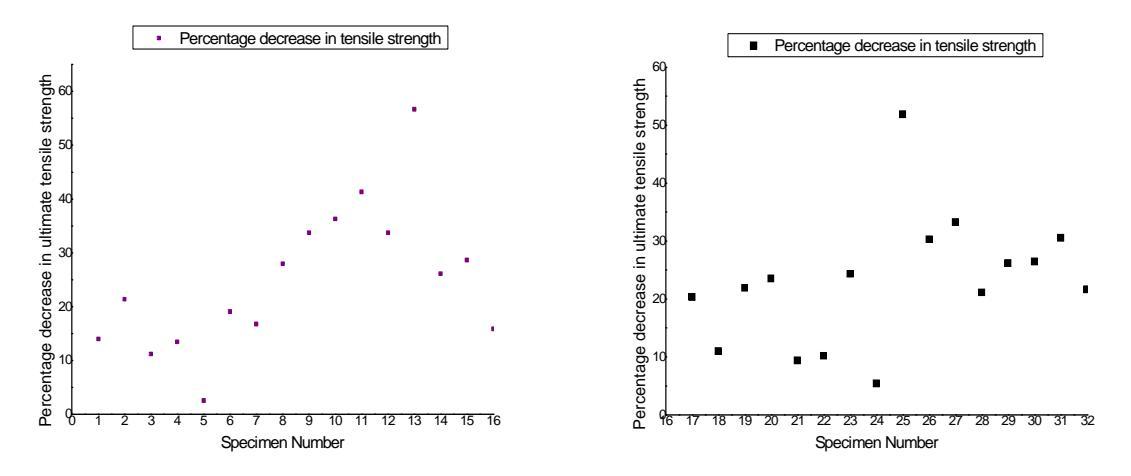
Fig. 3.21 Percentage decrease in UTS of specimen in water at 45°C

Fig. 3.22 Percentage decrease in UTS of specimen in water at 55°C

The reason for decrease in ultimate tensile strength and change in percentage tensile strength seems to be the continuous degradation due to hygrothermal load which affected the epoxy and fibre strength. Further in NaOH baths the reason for such large reduction is that fibre has been subjected to chemical attack as well which had made it loose strength and further supporting with SEM which also shows that fibre has been eaten up and its circularity has changed.

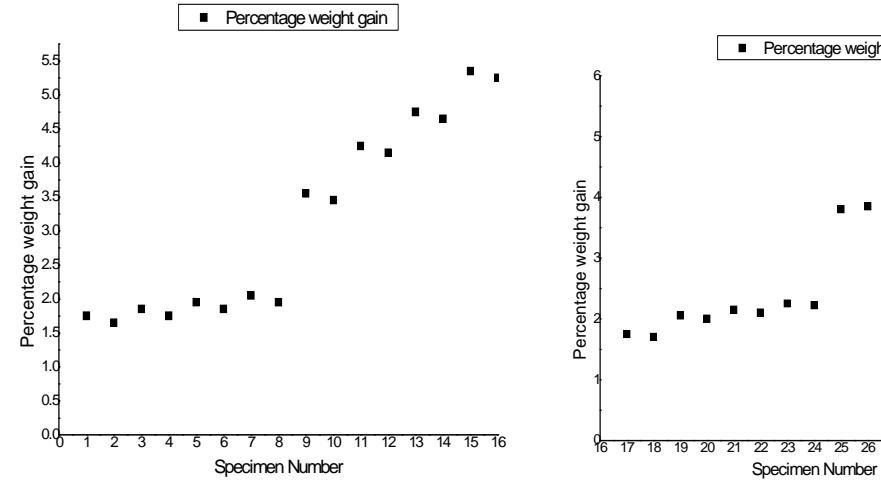
Fig. 3.25 Percentage weight gain of specimen in water at 45°C

Here $W_{(t)}$ is the total weight after time t, W_0 is the reference dry weight of the specimen before immersion in medium. The percentage weight gain (of moisture) was compared for various baths in Fig.3.25 - Fig.3.28. It could be easily noticed that in water baths the percentage weight gain is increasing with respect to time indicating that more moisture is absorbed after two months compared to first month) in all the specimen at various loads . There was marginal increase in weight gain of specimen at 55°C temperature as compared to specimen at 45°C). In the case of NaOH baths the percentage weight gain was also much higher in second month and also it was much higher with respect to water baths in both the months. The average weight gain in water baths was 3.53% at 45 degree Celsius and 4.0% at 55 degree celsius. But in NaOH baths average values were 11.38% at 45 degree Celsius and 13.67% at 55 degree Celsius. The reason for the increase in percentage weight gain in both baths is obvious as with time the pores of epoxy will loosen due to given hygrothermal load giving way to moisture. But in case of NaOH baths the weight gain was much higher due to the chemical attack on the fibre periphery as could be seen in SEM images, creating more voids to hold more moisture. The graphical comparisons of the percentage weight gain by various specimen are:

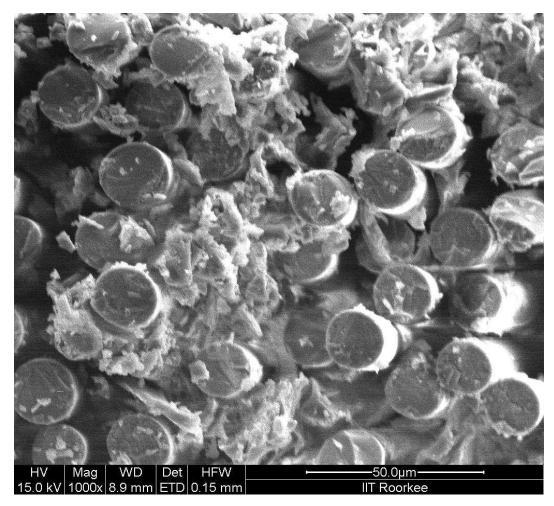
Fig. 3.29 SEM of cross-section

The SEM images (Fig.3.29 and Fig 3.30) for the GFRP composite specimen taken at 1000 X magnification from their cut-cross-section and cut-longitudinal-section at the start of testing, before exposure to hygrothermal loads show a fibre epoxy composite with fibres densely embedded in epoxy matrix with epoxy surrounding completely the fibres which maintain their circularity and suggest good strength. The SEM image (Fig. 3.30) of cut-longitudinal-section show cylindrical unbroken long fibres with no damage.

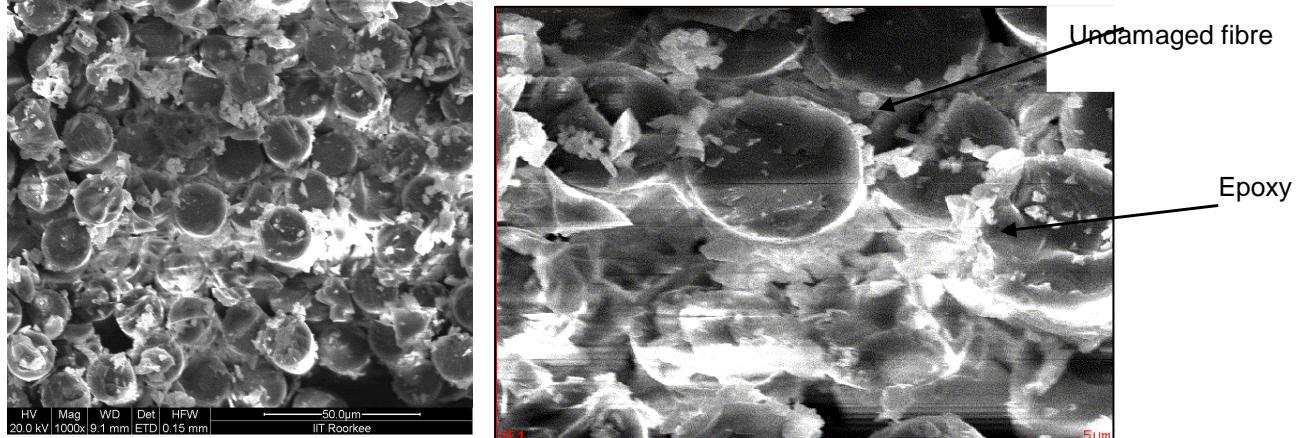
1) The SEM images of composite specimen which were subjected to 20% loading (T1, 1 month) shown below in Fig 3.31 and Fig 3.32 show undamaged circular fibres and epoxy smearing the surface of the fibres completely in small irregular lumps probably due to absorption of water by epoxy.

Fig.3.31 SEM image of specimen 1

Fig.3.32 SEM image of specimen 1 for EDS

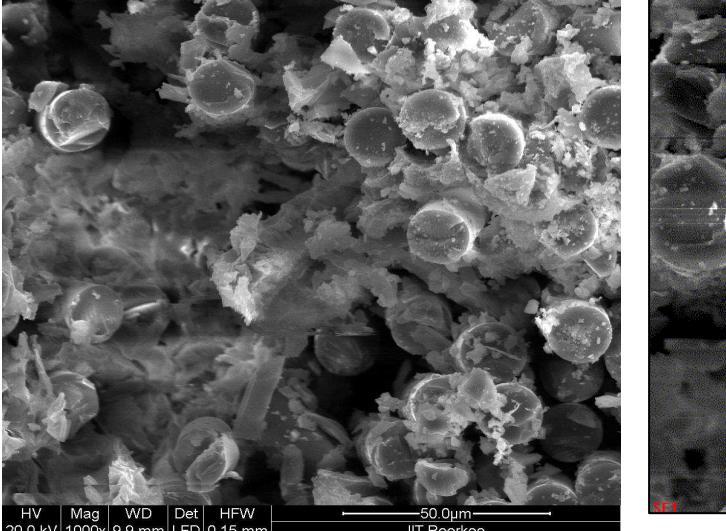
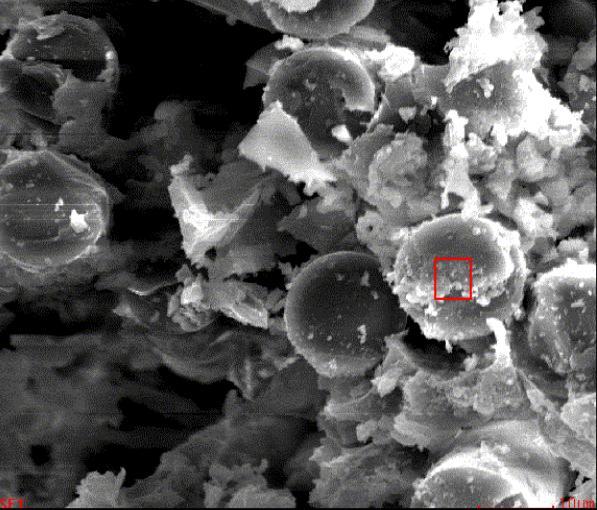
The SEM images of specimen which were subjected to 60% loading (T1, 1month) shown below indicate no damage to the circular fibre, whereas lumping of epoxy is clearly evident due to its hardening by absorption of water, also voids are evident in the epoxy matrix indicating a loss of strength in the composite. :

Fig. 3.35 SEM image of specimen 5 Fig. 3.36 SEM image of specimen 5 for EDS The SEM images of specimen which were subjected to 80% loading (T1, 1month) are shown below, they indicate no damage to the circular fibre, whereas lumping of epoxy is clearly evident due to its hardening by absorption of water, also large number of voids are evident in the epoxy matrix surrounding the fibres indicating loss of strength.

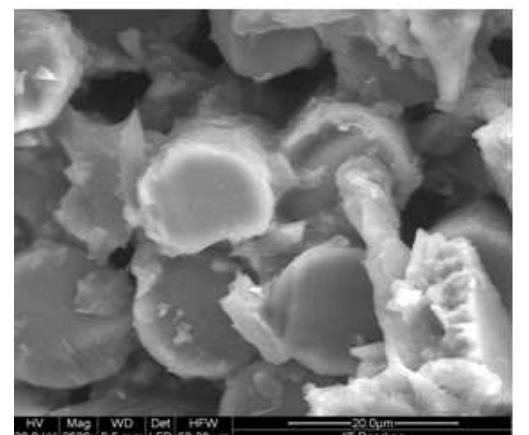
The SEM images of specimen which were subjected to 20% loading (T2, 1month) shown below indicate damaged fibre with change in circularity of the fibre, small amount of lumping of epoxy is also visible due to its hardening by absorption of water.

Fig.3.39 SEM image of specimen 33

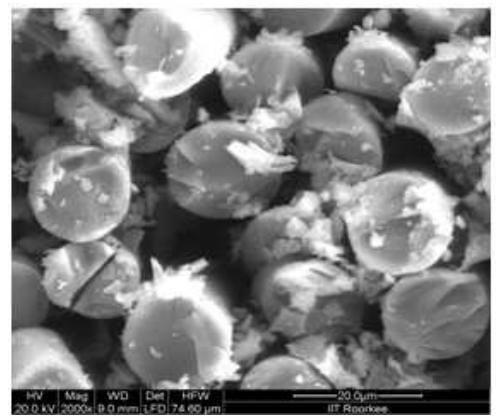
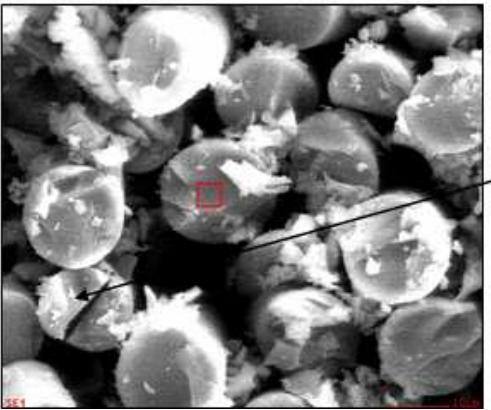
The SEM images of specimen which were subjected to 40% loading (T2, 1month) shown below clearly show fractured fibre surface, lumping of epoxy to a greater degree is clearly visible.

Fig.3.41 SEM image of specimen 35

Fig.3.42 SEM image of specimen 35 for EDS

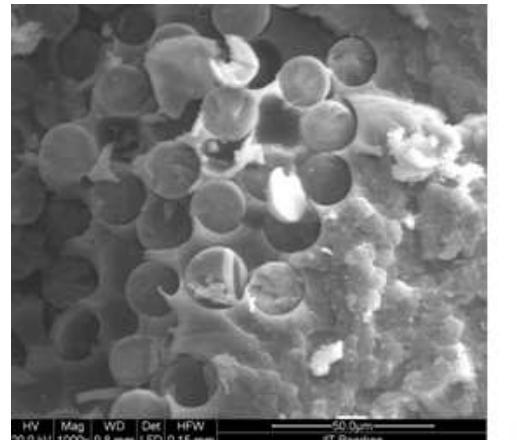
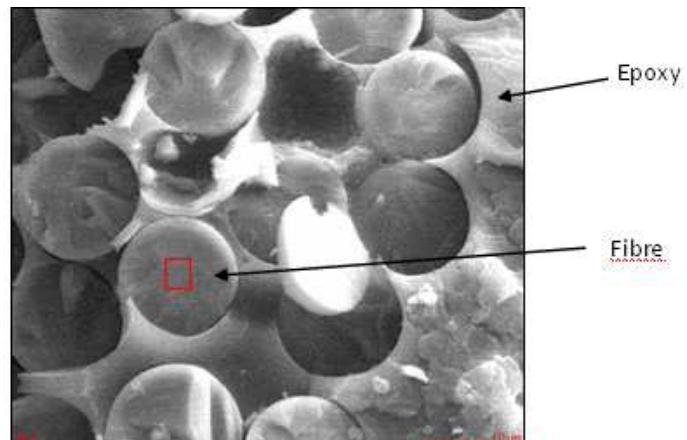
The SEM images of specimen which were subjected to 60% loading (T2, 1month) shown below indicate damaged fibre (changed circularity of fibre) and lumping of epoxy over fibre surface.

Fig.3.43 SEM image of specimen 37

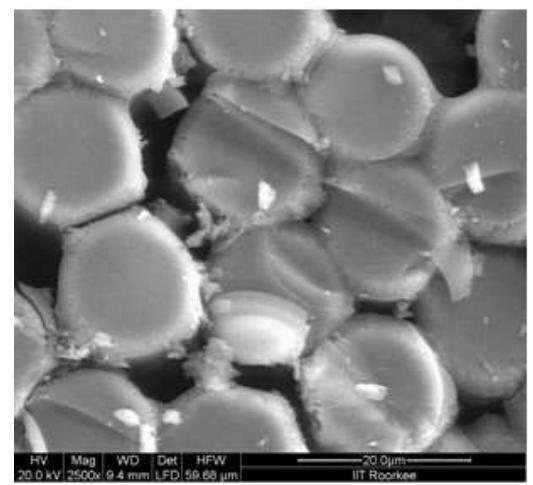
The SEM images of specimen which were subjected to 80% loading (T2, 1month) shown below indicate circumferential damage to fibre, and some lumping of epoxy over the fibre surface.

Fig.3.45 SEM image of specimen 39

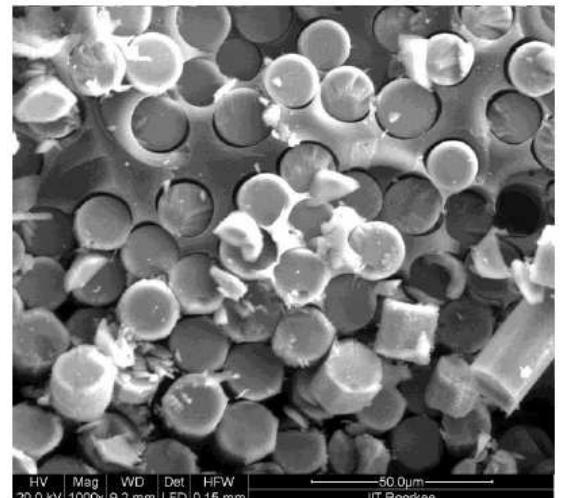
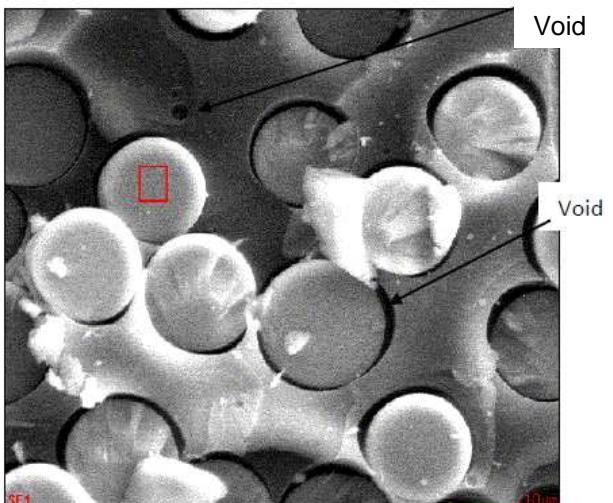
The SEM images of specimen which were subjected to 20% loading (T3, 1month) shown below clearly indicate delamination of the fibres from the epoxy matrix, some amount of lumping of matrix is also observed.

Fig.3.47 SEM image of specimen 49

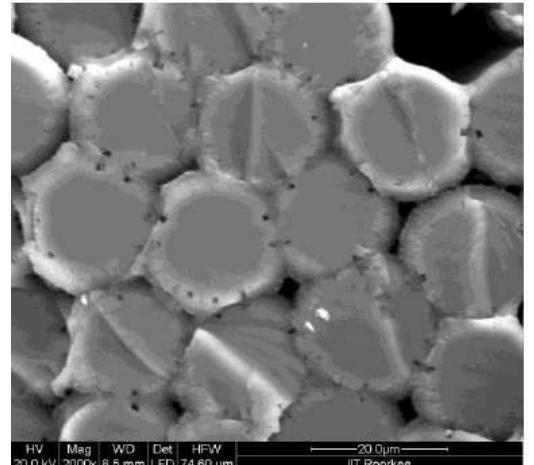
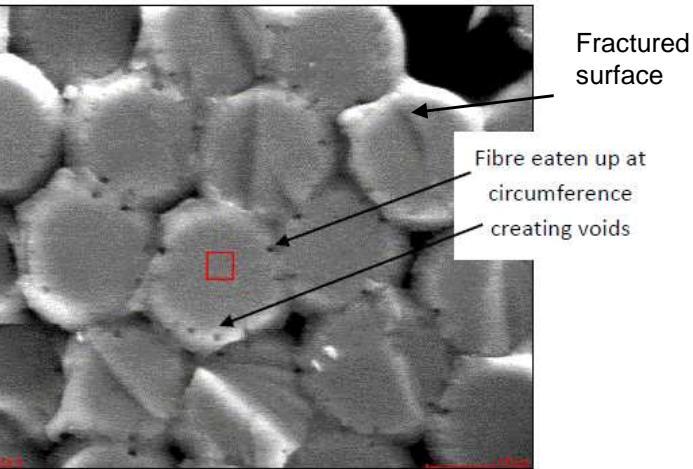
The SEM images of specimen which were subjected to 40% loading (T3, 1month) shown below indicate fibre being eaten up at the circumference and voids being formed, the fracturing of the fibre surface is also visible in fibre surface.

Fig.3.49 SEM image of specimen 51

Fig.3.50 SEM image of specimen 51 for EDS

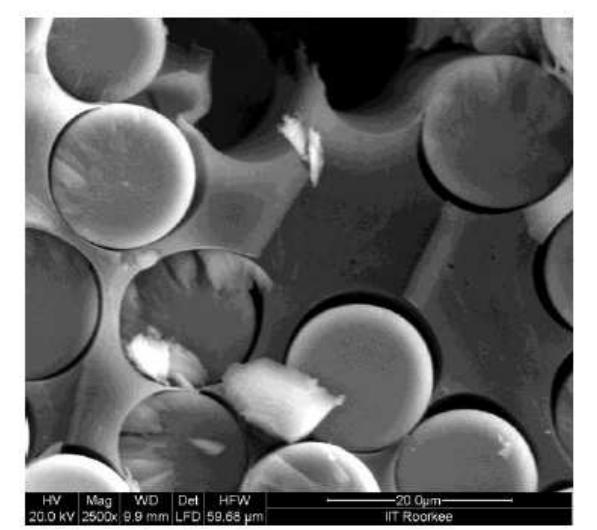
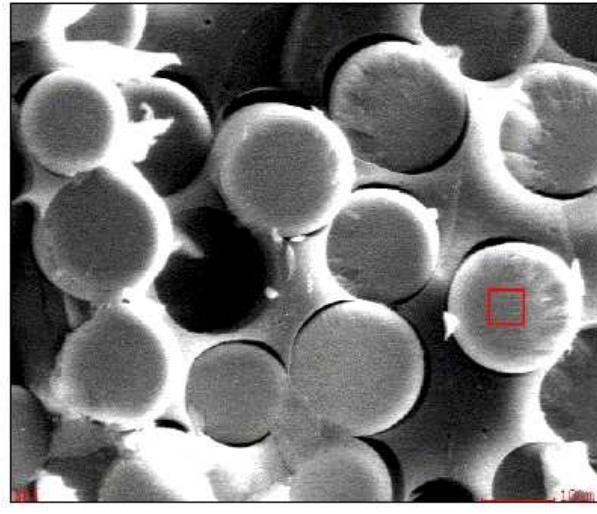
The SEM images of specimen which were subjected to 60% loading (T3, 1month) shown below clearly indicate delamination of the fibres from the epoxy matrix in form of fibre pullout, some amount of lumping of matrix is also observed, though epoxy appears as a cohesive matrix.

Fig.3.51 SEM image of specimen 53

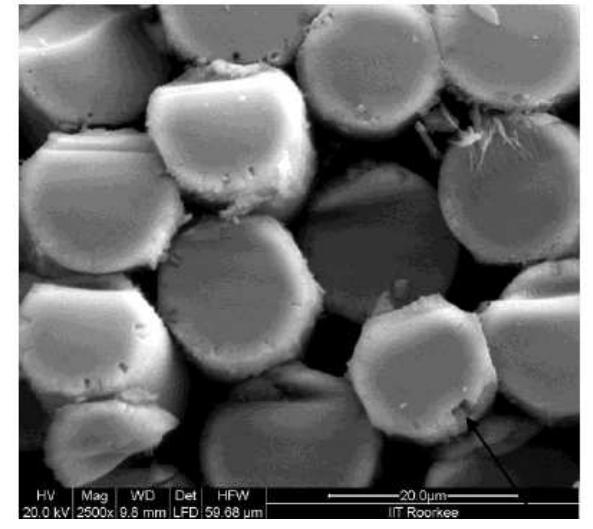
The results of specimen which were subjected to 80% loading (T3, 1month) shown below clearly indicate fibre damage (change in circularity), fibre fracture, voids between fibres in epoxy matrix.

Fig.3.53 SEM image of specimen 55

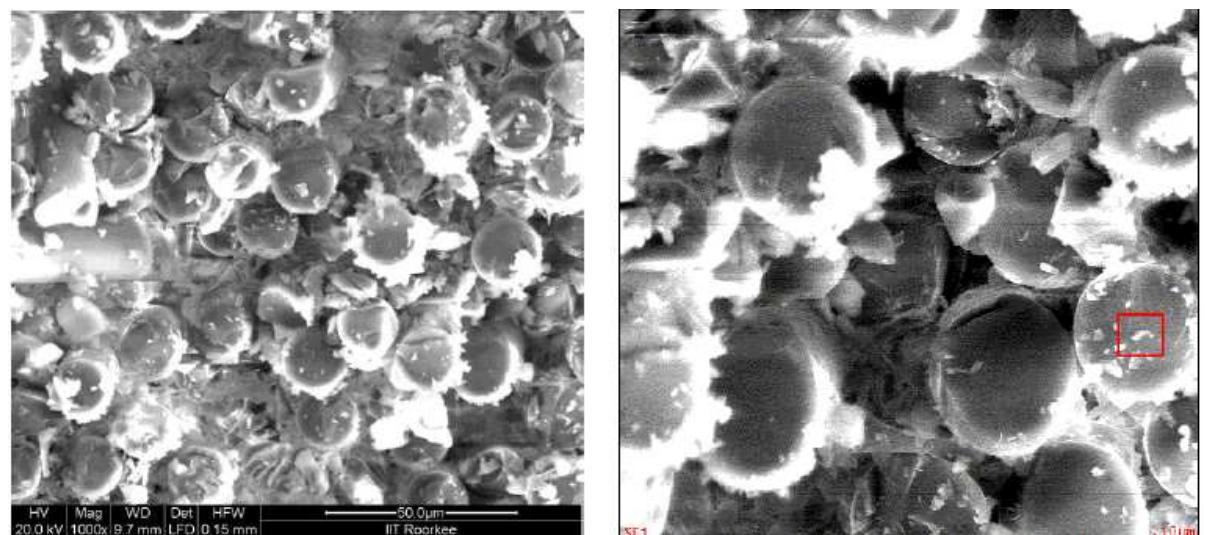
The SEM images of specimen which were subjected to 60% loading (T4, 1month) shown below indicate an absence of cohesive epoxy matrix with lumps epoxy covering the undamaged fibres.

Fig.3.59 SEM image of specimen 21

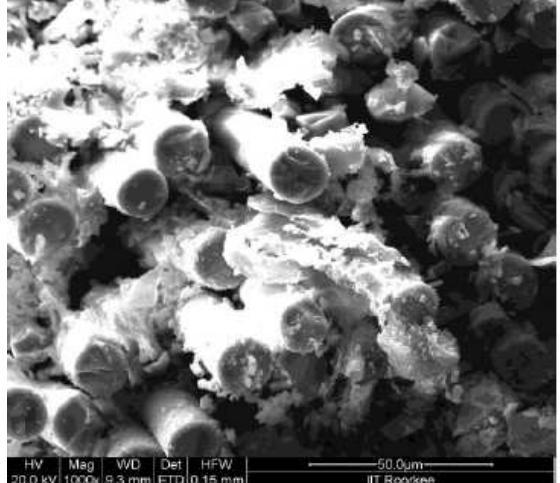
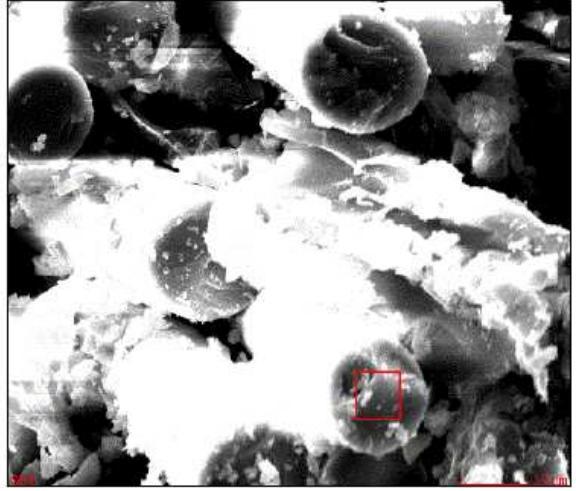
The SEM images of specimen which were subjected to 20% loading (T1, 2months) shown below indicate degeneration of epoxy matrix, extensive void formation between fibres, flaking of epoxy is clearly evident, it appears as though epoxy has dissolved away from the surface, as protruding undamaged fibres are visible. :

Fig.3.63 SEM image of specimen 9 Fig.3.64 SEM image of specimen 9 for EDS The SEM images of specimen which were subjected to 40% loading (T1, 2months) shown below clearly show flaking of epoxy, which smears the fibre surface forming lumps, the degeneration of epoxy matrix is clearly visible, though no damage to fibres (no change in circularity, or fibre fracture) is observed.

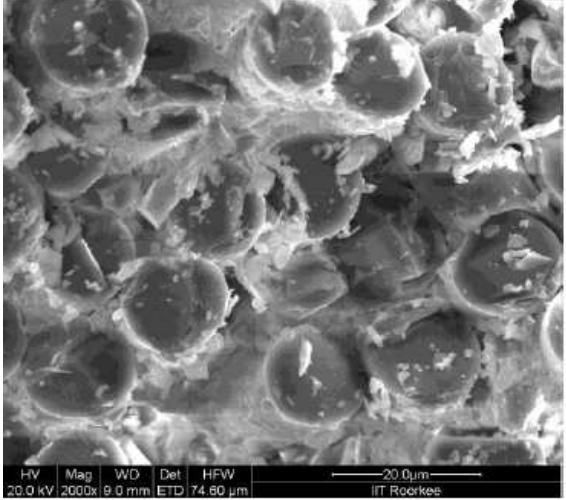
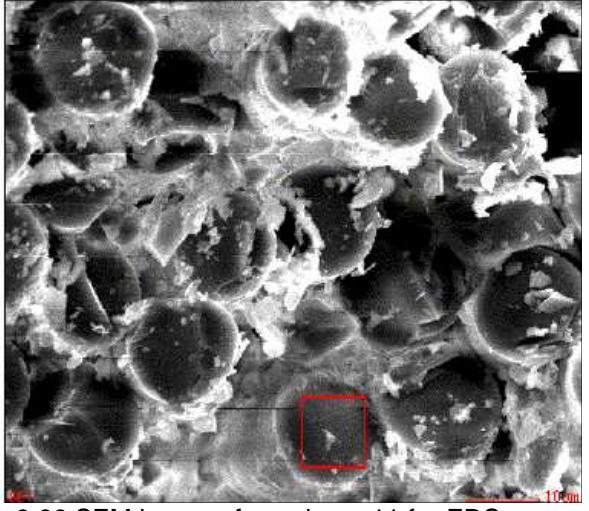
Fig.3.65 SEM image of specimen 11

Fig.3.66 SEM image of specimen 11 for EDS

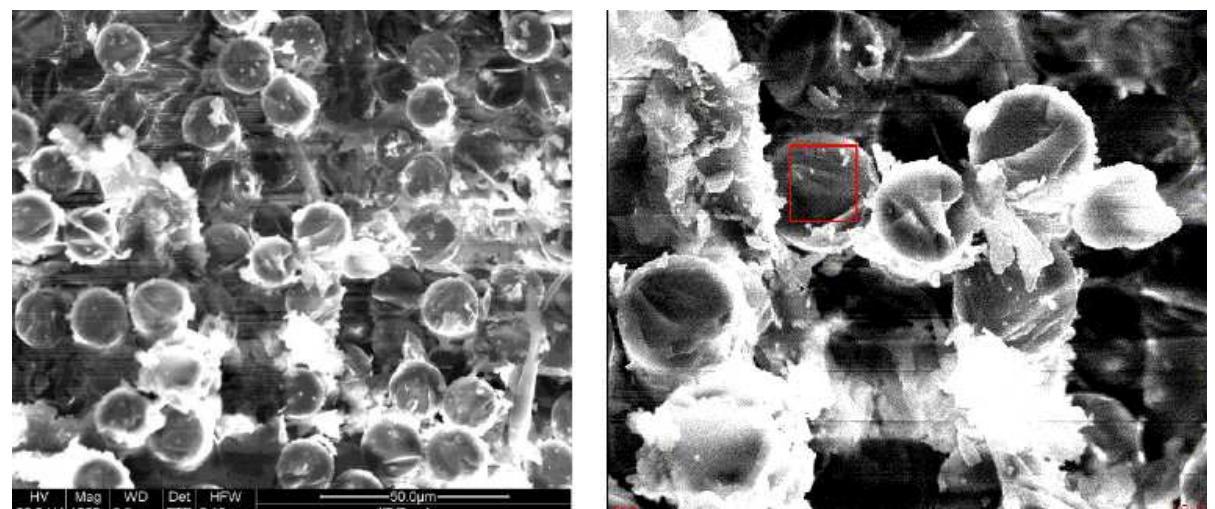
The SEM images of specimen which were subjected to 60% loading (T1, 2months) shown below indicate degeneration of epoxy matrix, void formation between fibres, the flaking of epoxy is clearly evident, though no fibre damage is seen.

Fig.3.67 SEM image of specimen 13

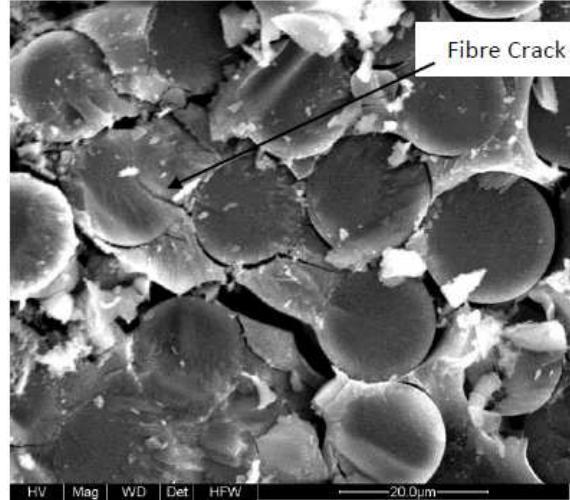
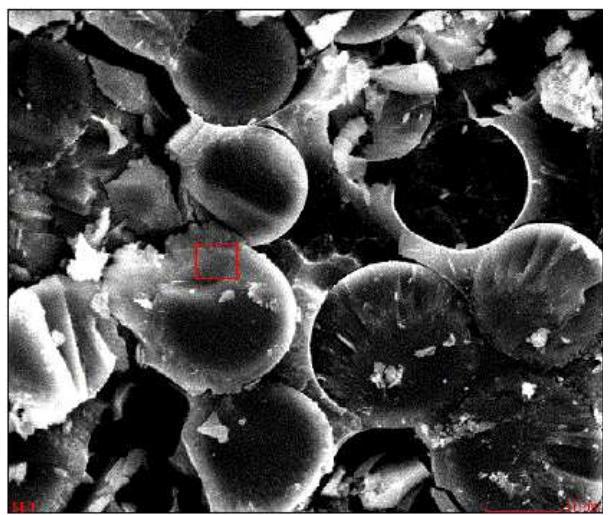
The SEM images of specimen which were subjected to 20% loading (T2, 2months) shown below clearly show the cracked fibre, fibre delamination and degradation of epoxy matrix , lumps of epoxy covering the fibre surface.

Fig.3.71 SEM image of specimen 41

Fig.3.72 SEM image of specimen 41 for EDS

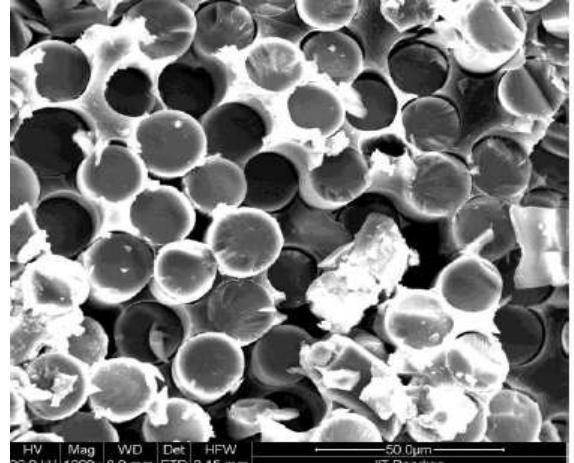
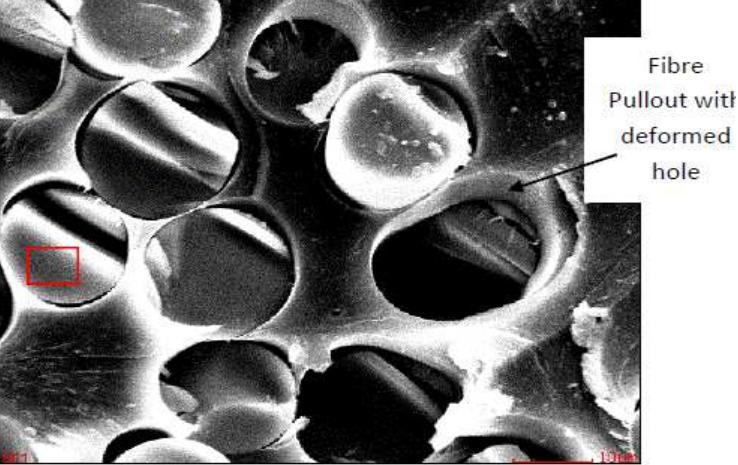
The SEM images of specimen which were subjected to 40% loading (T2, 2months) shown below show extensive degradation of epoxy matrix with fibre pullout, damage of fibres, appearance of voids between fibres.

Fig.3.73 SEM image of specimen 43

Fig.3.74 SEM image of specimen 43 for EDS

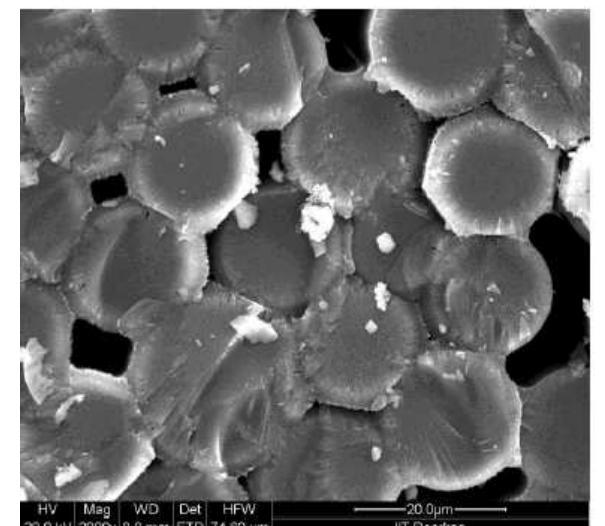
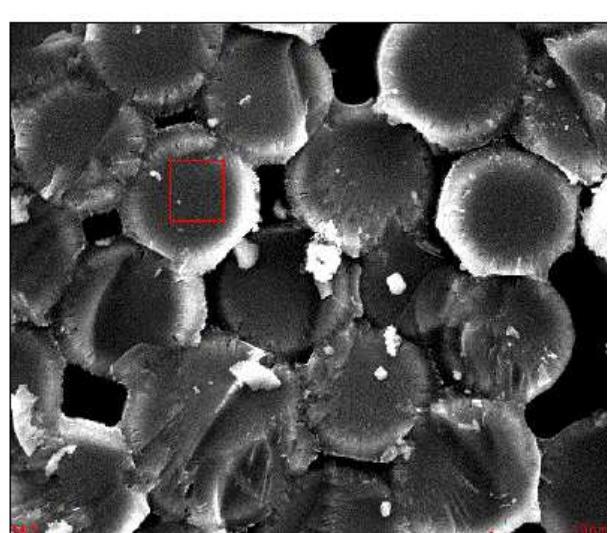
The SEM images of specimen which were subjected to 60% loading (T2, 2months) shown below show damaged fibres, voids in matrix between fibres, degradation of epoxy matrix with epoxy forming small lumps over fibre surface.

Fig.3.75 SEM image of specimen 45

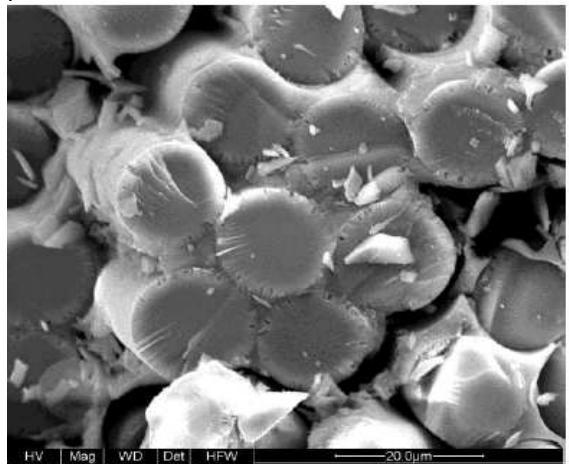
The results of specimen which were subjected to 80% loading (T2, 2months) shown below clearly show protruding fibres, degraded epoxy matrix, voids between fibres resulting in fibre pullout and fibre delamination besides fibre damage is also observed. :

Fig.3.77 SEM image of specimen 47

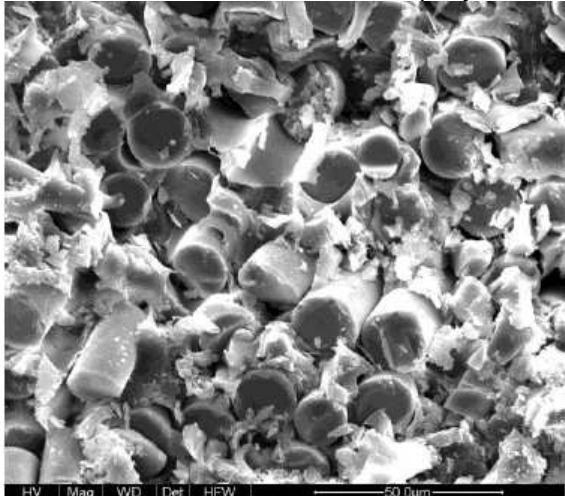
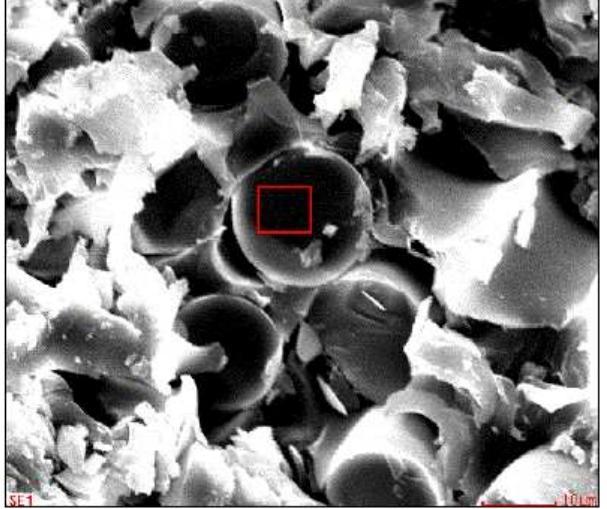
The SEM images of specimen which were subjected to 20% loading (T3, 2months) shown below show the degraded epoxy matrix with epoxy flakes covering the protruding damaged glass fibres, voids between fibres in the epoxy matrix.

Fig.3.79 SEM image of specimen 57

Fig.3.80 SEM image of specimen 57 for EDS

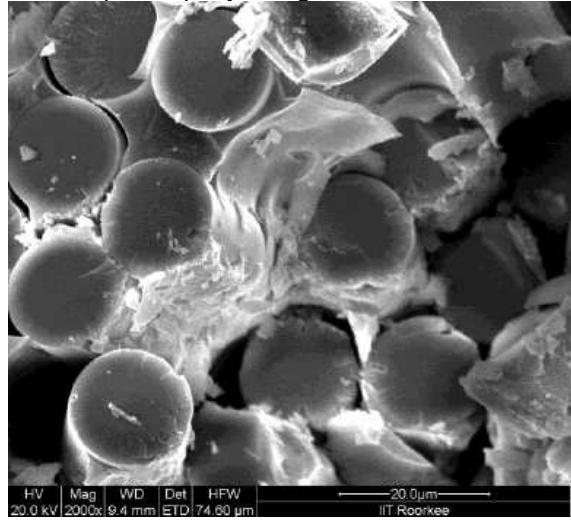
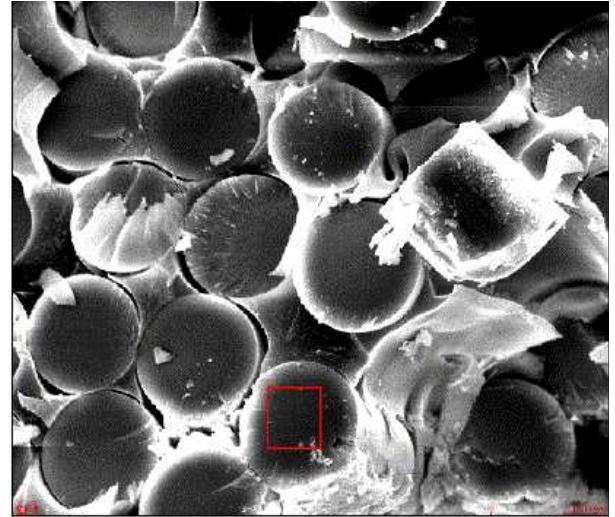
The results of specimen which were subjected to 40% loading (T3, 2months) shown below show fibre delamination and voids between fibres. It also shows fibre damage (change in circularity) and lumps of epoxy being formed over the fibre surface.

Fig.3.81 SEM image of specimen 59

Fig.3.82 SEM image of specimen 59 for EDS

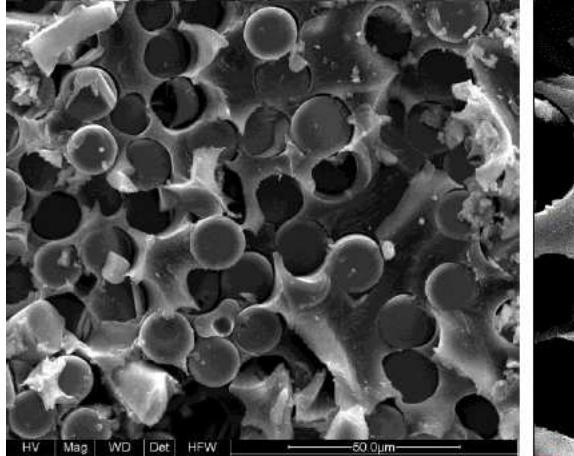
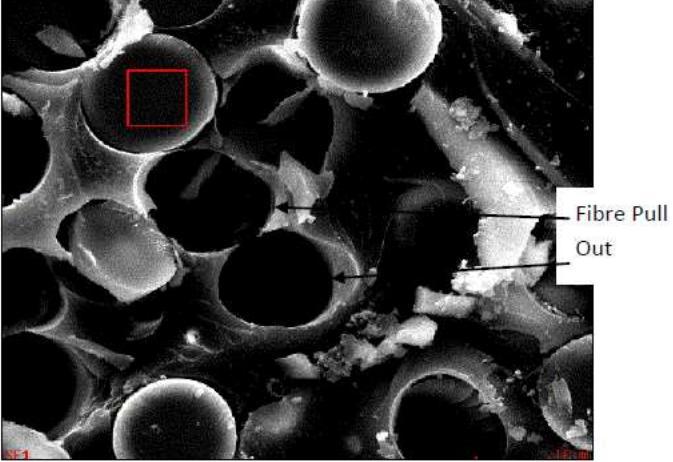
The results of specimen which were subjected to 60% loading (T3, 2months) shown below shows fibre pullout, formation of voids between fibres, fibre damage (change in circularity of fibres):

Fig.3.83 SEM image of specimen 61 Fig.3.84 SEM image of specimen 61 for EDS The SEM images of specimen which were subjected to 80% loading (T3, 2months) shown below show fibre cracking, change in fibre circularity, formation of voids, fibre delamination, degradation of epoxy matrix, smearing of epoxy over fibre surface.

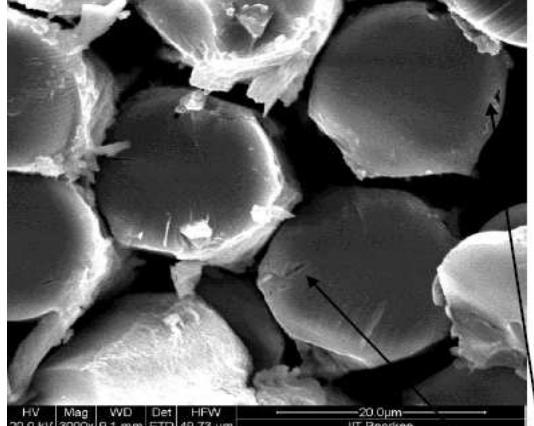
Fig.3.85 SEM image of specimen 63
