Project UpWind

Contract No.: 019945 (SES6) "Integrated Wind Turbine Design"

ENVIRONMENTAL DEGRADATION OF GLASS FIBRE REINFORCED POLYMER COMPOSITE

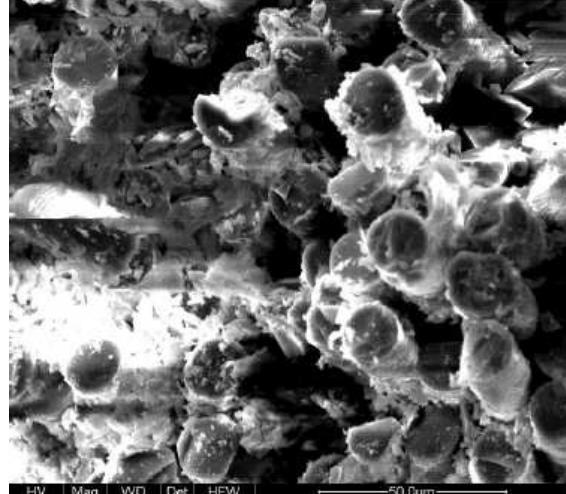
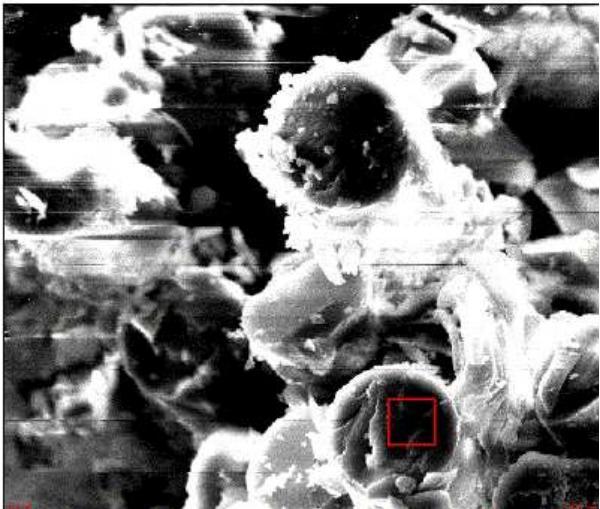
The SEM images of specimen which were subjected to 20% loading (T4, 2months) shown below show undamaged fibre, degradation of epoxy matrix forming flakes around the fibre surface.

Fig.3.87 SEM image of specimen 25

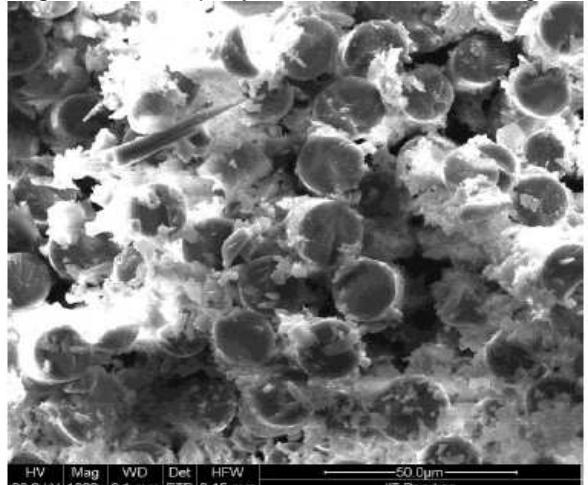
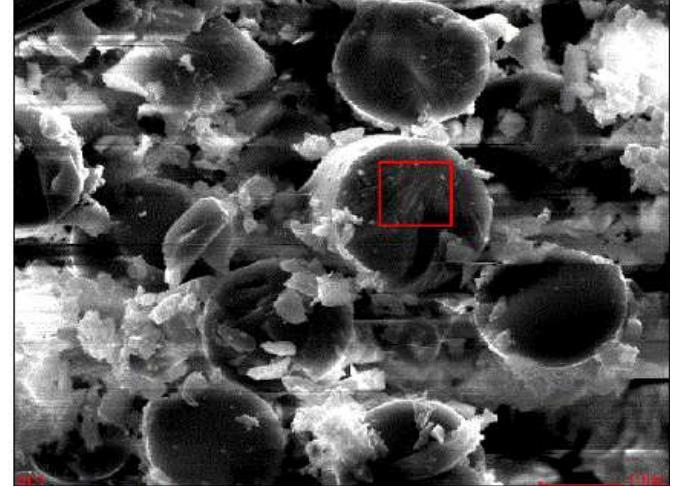
The SEM images of specimen which were subjected to 40% loading (T4, 2months)shown below show mostly undamaged fibre with only a rare ones with changed circularity, extensive degradation of epoxy matrix is visible forming lumps of epoxy smearing the fibre surface.

Fig.3.89 SEM image of specimen 27 Fig.3.90 SEM image of specimen 27 for EDS The SEM images of specimen which were subjected to 60% loading (T4, 2months) are shown below. They show damaged fibres and degraded epoxy matrix, with epoxy smearing the fibre surface. No fibre delamination or fibre pullout is observed.

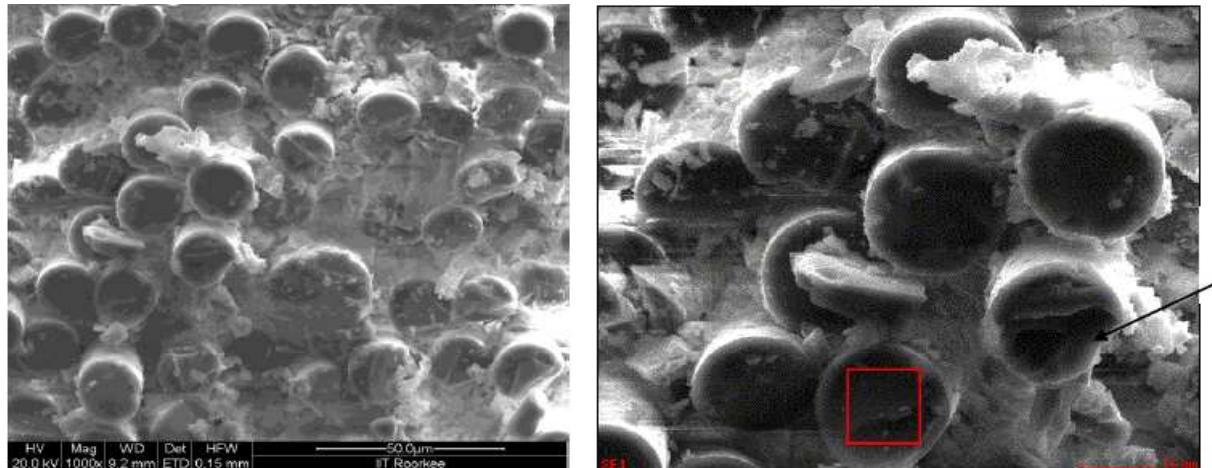
Fig.3.91 SEM image of specimen 29

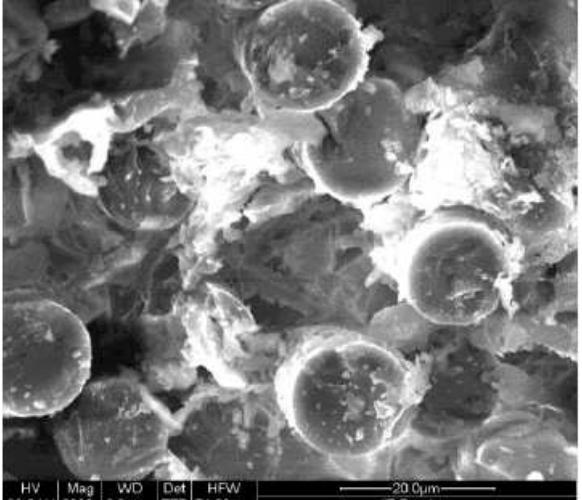
The SEM images of specimen which were subjected to 80% loading (T4, 2months) shown below show changes in fibre shape (circularity), smearing of epoxy over the fibre surface resulting in complete degradation of epoxy matrix. Some voids are also seen in the epoxy matrix surrounding the fibres.

- Fig.3.93 SEM image of specimen 31

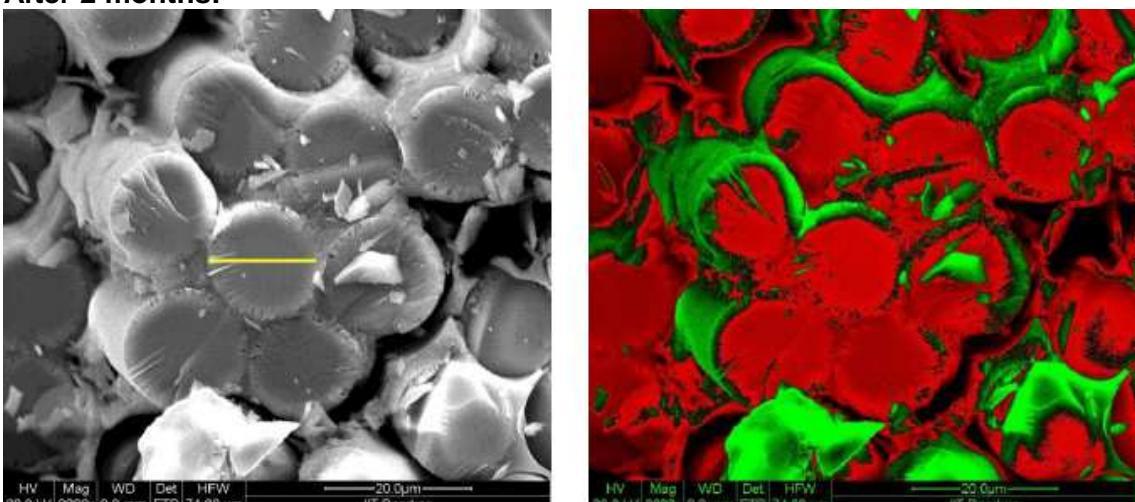
Fig.3.96 (Left) SEM image of specimen 47, (Right) same SEM image by Image Analyser

The image analysis of all the SEM images was done in order to compare the area fraction of both epoxy as well as of the fibre and the circularity changes in the fibre. The commercially available software Image J was used for analysis of images. Image J is open source software developed by National Institute of Health (USA) and is considered as a powerful tool for image analysis. Few representative images after analysis by software are shown from Fig.3.95 to Fig.3.97. The red area represents the fibre, the green is taken as epoxy, and some black region observed is taken as voids. The yellow line represents the diameter of fibre.

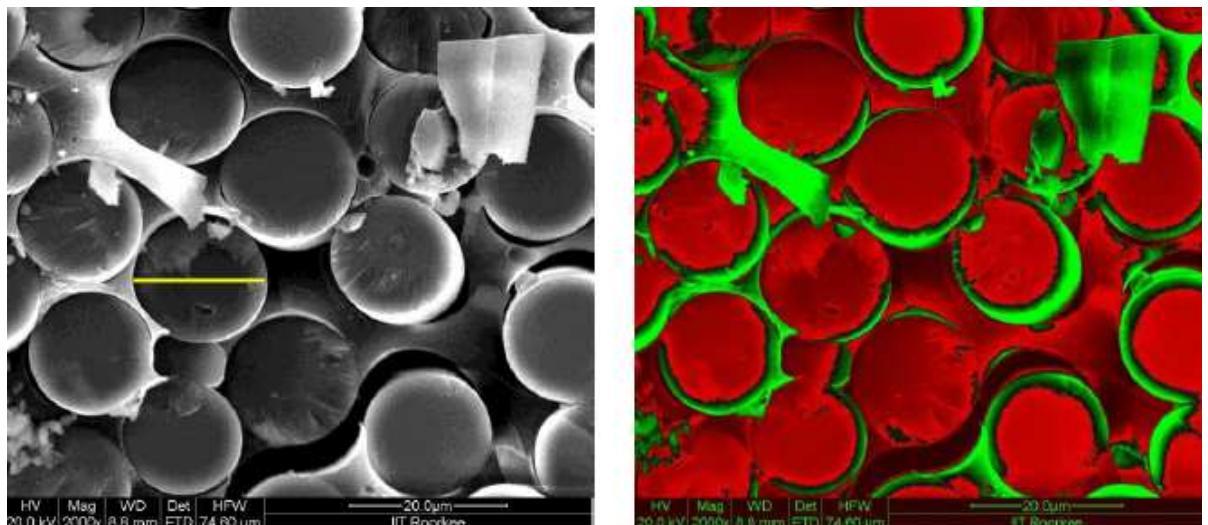
Fig. 3.97 (Left) SEM image of specimen 63, (Right) same SEM image by Image Analyser

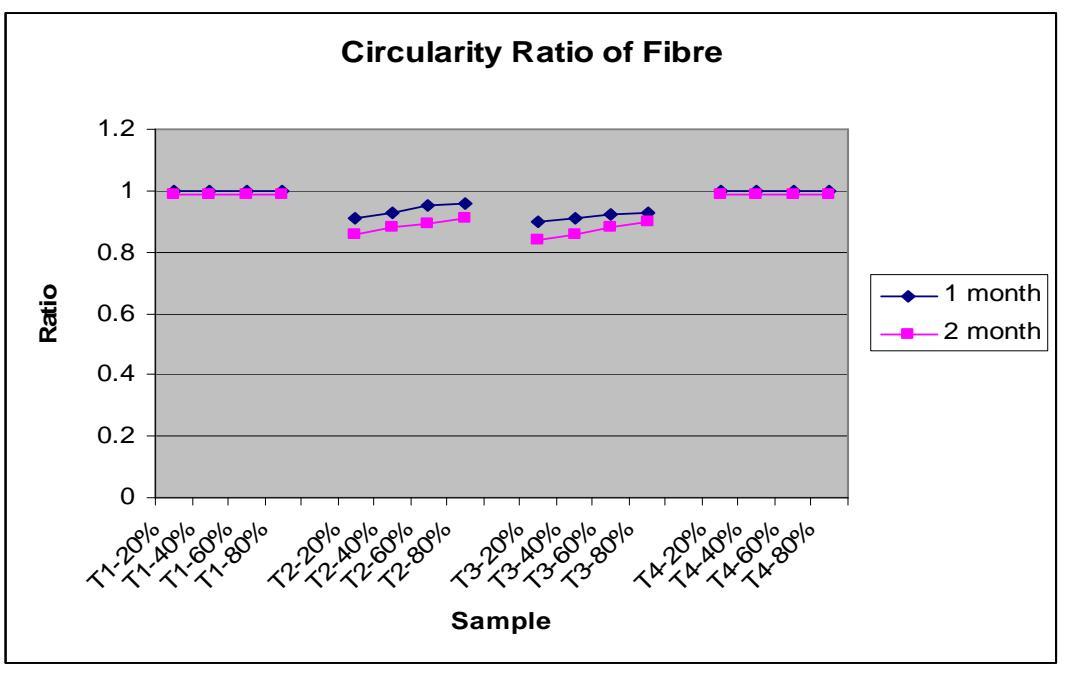
Fig.3.100 Comparison of Circularity Ratio of fibre with respect to time

The Circularity ratio (Fig.3.100) values have not changed in both the water baths for first month at all loads. For second month also there is no change in fibre circularity in water baths. Whereas circularity change is observed in NaOH baths in first month itself followed by further decrease in circularity in second month. The reason for such a trend is eating up of fibre by the NaOH attack leading to change in shape with most damage on circumference of fibres.

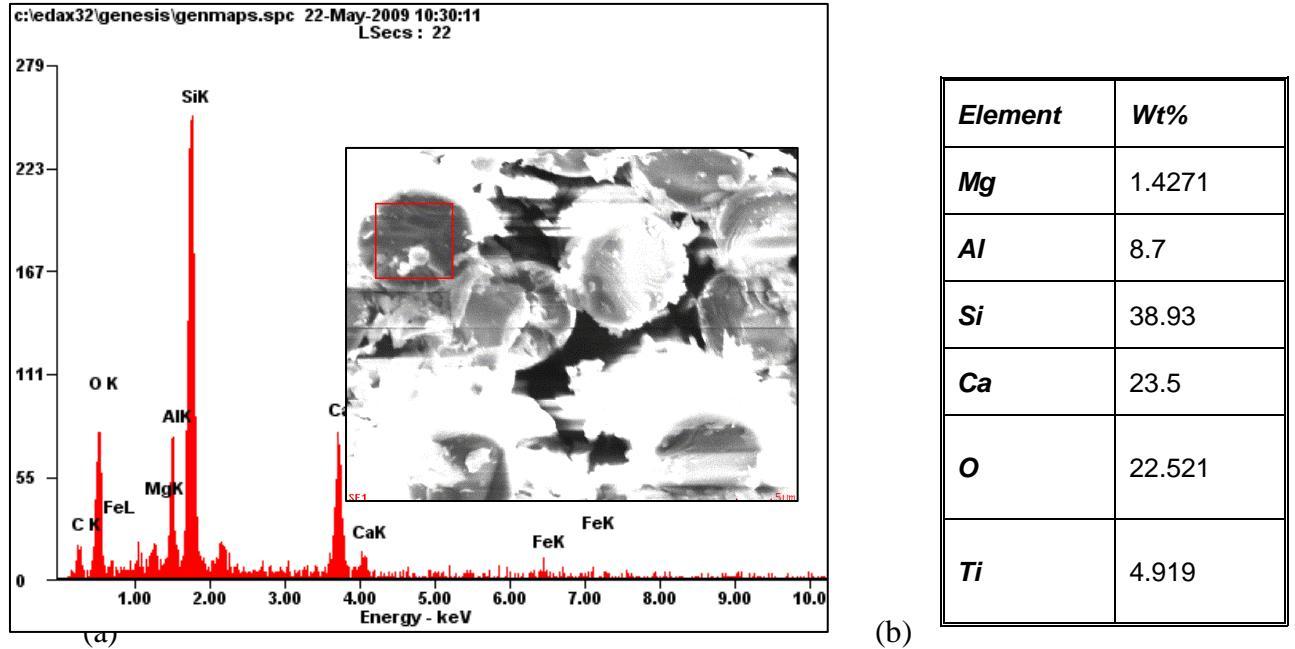
The SEM+EDS measurements (shown in Fig 3.101) which are used generally for qualitative assessment were taken for the various specimen to assess the change in chemical composition of composite specimen with environmental degradation. The percentage elemental composition for specimen in various baths and with various pre-stretched loads was plotted in graphs shown in Figure 3.102 to Figure 3.112.

Fig.3.101 (a) Energy vs Electron volt graph at start for initial specimen, (b) Element percentage taken by EDS

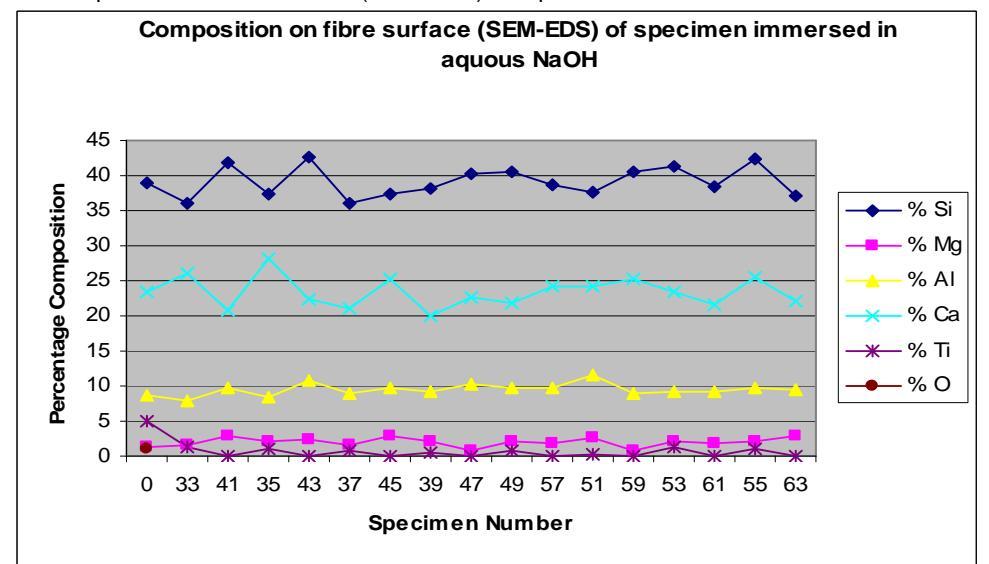
Fig. 3.104 Composition on fibre surface (SEM-EDS) for specimen immersed in aq NaOH bath

From the analysis of the graphs shown in Fig.3.102 to Fig.3.112, following observations were made: The Fig 3.102 shows the elemental composition on the fibre surface of all the specimen immersed in water and aquous NaOH baths and of the unexposed specimen (specimen 0). It is easily seen that in the specimen immersed in aquous NaOH the percentage composition of silicon is generally higher as compared to that of specimen immersed in water baths and is also higher than the unexposed specimen. Whereas oxygen percentage values in water immersed specimen are generally higher than those observed for specimen in aquous NaOH baths. For the calcium percentage values similar trend is observed. The aluminium percentage values are nearly the same in aquous NaOH immersed specimen as compared to water immersed specimen and unexposed specimen. There is not any change in percentage magnesium composition for specimen immersed in both water and aquous NaOH baths and unexposed specimen, whereas titanium composition is decreasing in both water and aquous NaOH baths,
